Reconstruction Steps to Improve Performance of a Dam Bottom Outlet Regulation Gate

Filip Stojkovski, Sašo Belšak, Robert Broz

ISKRA IMPULS d.o.o., SLOVENIA

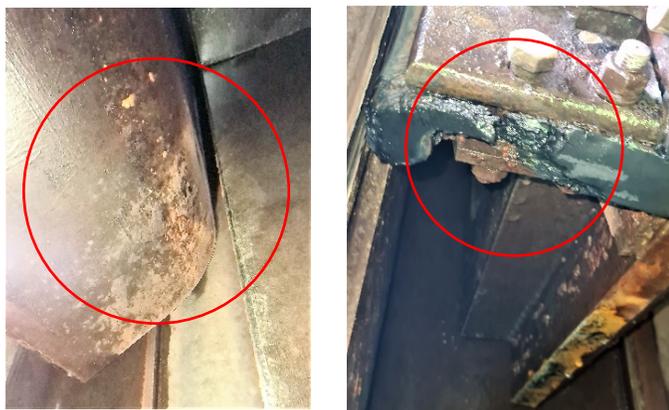
At first site, several damages were noticed. Primarily, the gate lip and the bottom seals were accessible to inspect eventual damages. A missing part was noticed on the bottom face of the side seal, where local water leakage was allowed. Second, as the discharge rates through the bottom outlet are excessive and the flow velocities are high, the water wears rocks and stones which hit the bottom of the gate and caused local damages on the gate body and the seals (Figure 1).

Figure 1. Local damages at the gate bottom (left – gate lip caverns from rock hits, right – side seal bottom face damage)

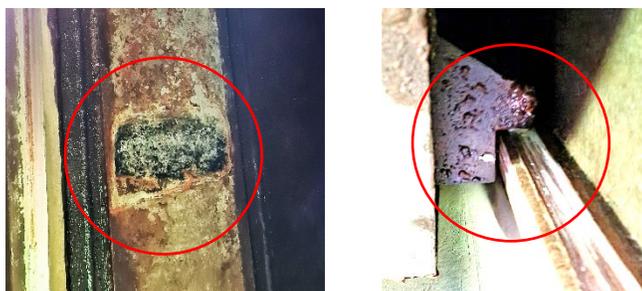
The following items described are the wheels and the wheel axles. Before reconstruction, damage was noticed on the wheel tracks, as the lower wheels which carry the highest loads were substantially pressed towards the wheel tracks and their initial rolling was blocked. That led to local damage of the wheel tracks, reducing the wheel rolling surface diameter and forcing the gate to slide towards the side bumpers, leading to increased friction and damages on the side sliding tracks (Figure 2).

Figure 2. Wheel track damage (left) and side bumper contact with the sliding track (right)

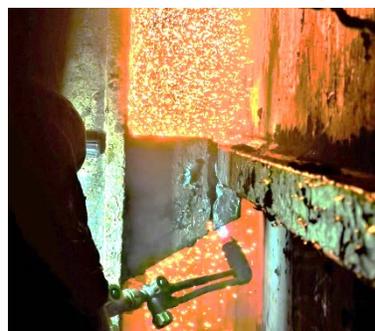
When the site was ready to perform gate dismantling, an interesting phenomenon was noticed – the gates center of gravity with the pre-described holes for the hydraulic cylinder and the hinges were miss-matched. The gate weight is app. 24 tons and when pulling out, the gate got stuck on the side bumpers and the side tracks. This situation was outrun by cutting out the side bumpers to release the gate and pulled out into the revision space (Figure 3). Later, new side bumpers were installed within the tolerances.

Figure 3. Side bumpers cut-out to release the stuck gate

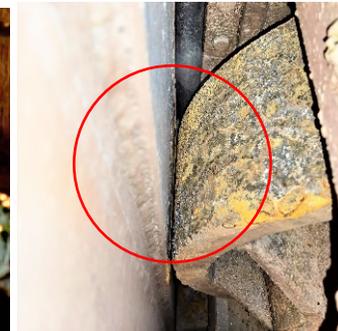
As the gate was pressed towards the side bumpers, the wheels were not performing contact with the wheel tracks, which is unacceptable (Figure 4). Also on Figure 4 it can be noticed the

surface damages on the wheel rolling surface which results in reducing the rolling diameter of the wheel, which increases the pressure on the seals. These damages were initially noticed and represent some of the main disadvantages of the gate which lead to increased lifting resistant forces of the gate, and negatively contribute towards performance of full lift, which was the main issue.

Figure 4. Wheel not in contact with wheel track

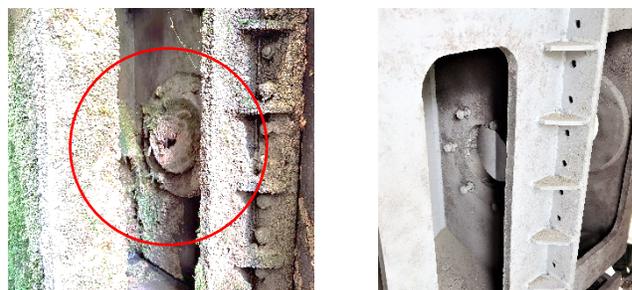
After dismantling all mechanical elements, sand blasting was applied on the gate body and the gate slots, to clean the surfaces and to make them rough to better accept the anticorrosive coating. Corrosion damages were noticed especially at the sections where the wheel axles covers were attached. On Figure 5 a comparison is shown before and after the sand blasting.

Figure 5. Before (Left) and after (Right) sand blasting

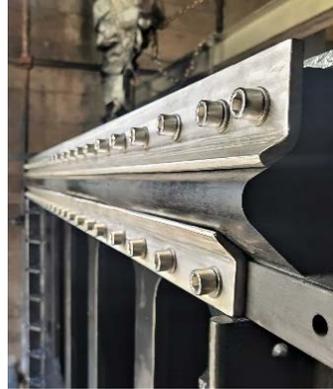
Figure 7. Gate top seal after refurbishment

The seals profiles are given on Figure 6 by JUS standards. Today's seals by European standards cannot fit in the pre-described sealing space. The seals between each other were glued to obtain a sealing unity. On Figure 7 the top seal is presented after refurbishment with the sealing plates and new bolts from stainless steel.

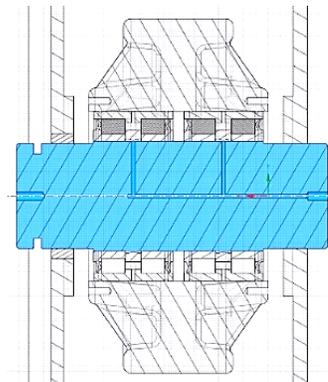
Figure 8. Wheel axle redesign

The wheels were refurbished and their axles were re-designed. The purpose of the re-design of the axels was to reduce the contact pressure inside the rolling surface and to reduce rolling friction, which will reduce the lifting forces and allow the gate to perform full opening. Primarily, the wheel was sent to a workshop for cleaning, machining and the rolling surface was welded with stainless steel. The wheel axle hole diameter was decreased for 7 [mm] from Ø347 to Ø340 to put a pair of roller bearings packs with outer diameter of Ø340 and inner diameter of Ø220, compared to the old axle with outer diameter of Ø210. Also, the axle was bored with channels to allow lubrication of the roller bearings, where the old axle had self-lubricating copper bushings.

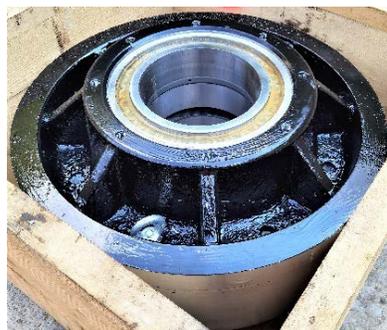
Figure 9. Refurbished wheel with welded stainless steel and packed with roller bearings

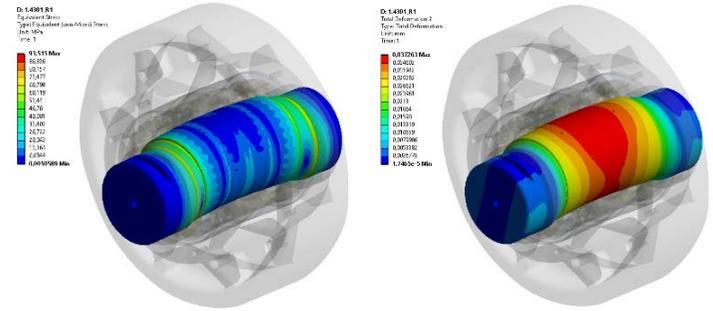
To perform this type of design, FEA simulations were carried to analyze the stress and strain behavior of the wheel assembly. The new design led to reducing the material grade quality from 1.4057 (original axle material) to 1.4301, obtaining a safety factor of the wheel of 1.355 (Figure 10).

Figure 10. FEA analysis of the redesigned wheel assembly

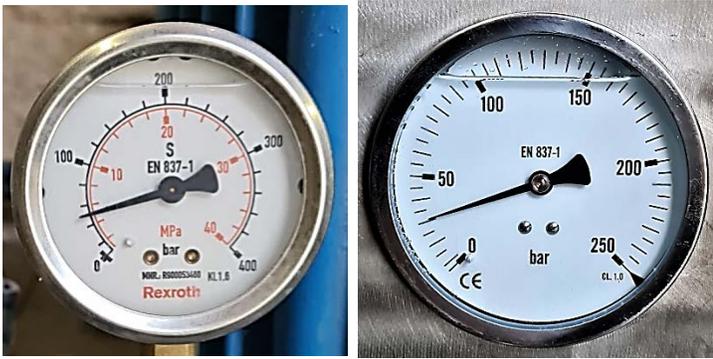
Dry tests were carried out to see the mechanical behavior of the gate of its own. The measured results showed no change in the natural frequency of the gate after the reconstruction. The measured natural frequency was obtained as 26.875 [Hz], showing that the harmonic response simulations from the previous chapter (26 [Hz]) show good correspondence with the measured values. Also, it was obtained that the lifting pressure was reduced by 19 [bar] after the reconstruction (Figure 17).

Figure 17. Dry lifting pressure comparison (left 50 [bar] – pre; right 31 [bar] – after reconstruction)

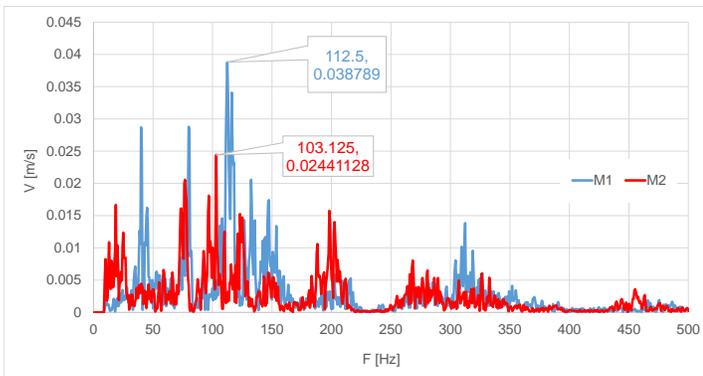
Figure 18. Vibration comparison for 6.25% opening

From figure 18, it can be seen that vibrations velocity after the reconstruction works was reduced by 37% and the vibration frequency for 8.3% for gate opening of 6.25%, and on figure 19, for gate opening at 12.5%, the vibration velocity was reduced by 67% and the frequency for 28.5%. Due the lifting, the pressure was measured needed to lift the gate. A reduce in the lift was obtained from 22 to 48% throughout the gate path.

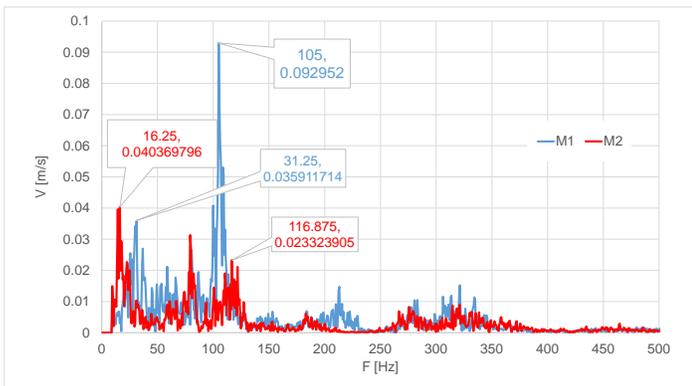
Figure 19. Vibration comparison for 12.5% opening
