Reconstruction Steps to Improve Performance of a Dam Bottom Outlet Regulation Gate

Filip Stojkovski, Sašo Belšak, Robert Broz

ISKRA IMPULS d.o.o., SLOVENIA

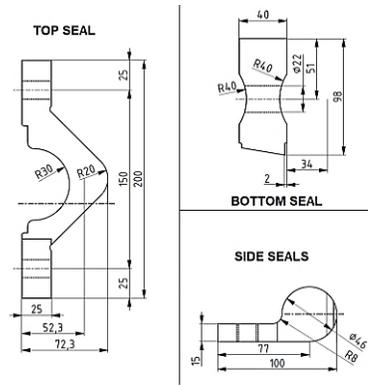
Figure 6. Gate seals profile dimensions by JUS standards

The seals profiles are given on Figure 6 by JUS standards. Today's seals by European standards cannot fit in the pre-described sealing space. The seals between each other were glued to obtain a sealing unity. On Figure 7 the top seal is presented after refurbishment with the sealing plates and new bolts from stainless steel.

Primarily, the seals' dimensions for the gate were made by JUS standards which needed to be specially molded from Nitrile Rubber with 50 Shore rubber hardness, to perform „soft“ contact with the sealing frame and to be pre-compressed within the allowable limits. The seal plates and bolts were completely replaced, made from stainless steel. The sealing frame in the lower gate slot was also made from stainless steel, where the damaged sections were refurbished by welding stainless steel on them, and then adjusting at the right thickness. As the gate lifts and gets in the upper slot, the seals are always in contact, and the gate performs sealing throughout the operating height. The material of the gate slot is structural steel and the seals must remain in contact all the way.

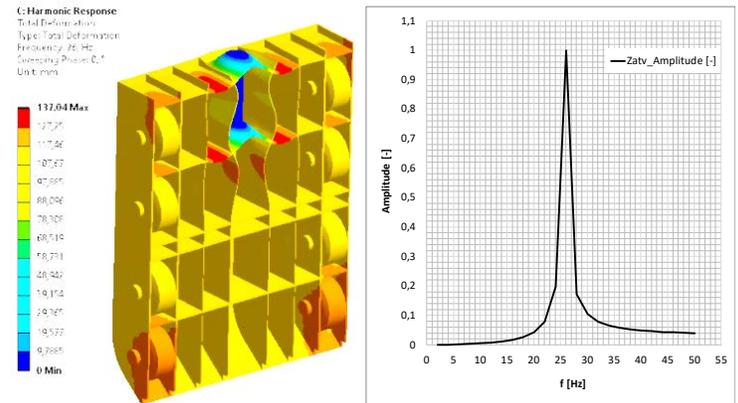
Figure 11. Harmonic response of the gate and its natural frequency at 26 [Hz]

Other mechanical FEA simulations were performed on the gate body, according to real measured material thicknesses, to obtain the stress and displacement behavior of the gate body and its critical sections, and also the determine the natural frequency of the gate, as later vibration measurements were performed to see how the reconstruction has overall influence on the gate improvement.

Dry tests were carried out to see the mechanical behavior of the gate of its own. The measured results showed no change in the natural frequency of the gate after the reconstruction. The measured natural frequency was obtained as 26.875 [Hz], showing that the harmonic response simulations from the previous chapter (26 [Hz]) show good correspondence with the measured values. Also, it was obtained that the lifting pressure was reduced by 19 [bar] after the reconstruction (Figure 17).

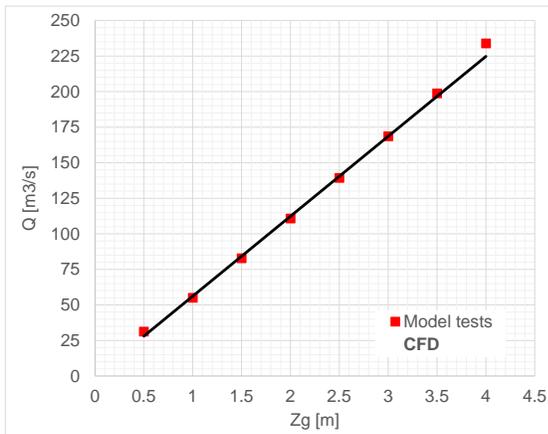
Figure 12. CFD obtained discharge rate compared with model tests data

As the primary criterion is to obtain self-closure of the gate, hydrodynamic forces estimation via CFD simulations is inevitable in the process. Using the Multiphase Flow Modelling approach with the Volume of Fluid (VOF) method, the gate was numerically tested from closed to opened position at different water levels in the reservoir. A 3D model was built, considering short segment of the bottom outlet and the outflow conditions in the atmosphere, considering a simplified terrain configuration behind the gate. The results of the CFD simulations show remarkable correspondence with the Model Tests of the bottom outlet performed 50 years ago.

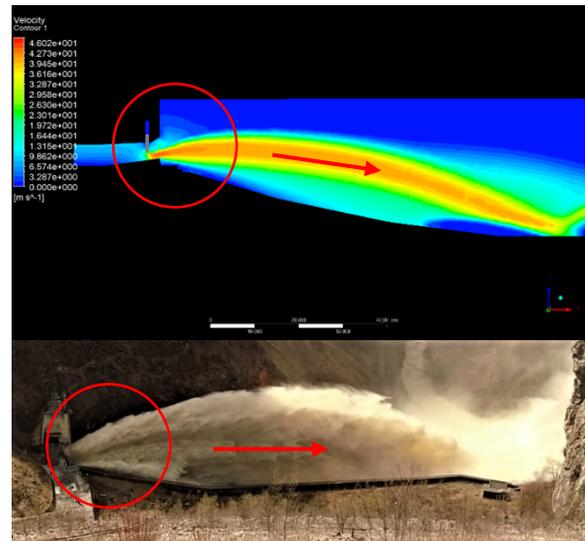
Figure 15. Gate opening at 37.5 [%]

The obtained results for the hydrodynamic forces showed that at every gate position, the forces are positive downwards which creates the Down-pull effect of the gate, leading towards self-closure of the gate (Figure 13). The water jet formation behind the gate from the CFD simulations was compared with drone footage, where at the same positions, the outflow conditions were filmed, showing similarity with the real operating conditions (Figure 14 and 15).

The jet formations behind the gate obtained with CFD simulations show good correspondence with the drone footage of the outflow conditions, where for smaller gate openings the jet is more humped and shortened, and for increased opening, is flattens and has increased length. Discharge rates depends from the water level in the reservoir, and it was obtained for maximal water level in the reservoir of app. $Q=250 \text{ [m}^3/\text{s]}$ for full gate opening.

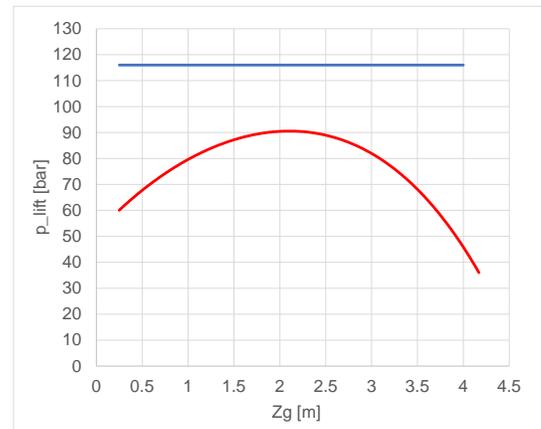
Figure 20. Lifting pressure comparison pre and after reconstruction

From figure 18, it can be seen that vibrations velocity after the reconstruction works was reduced by 37% and the vibration frequency for 8.3% for gate opening of 6.25%, and on figure 19, for gate opening at 12.5%, the vibration velocity was reduced by 67% and the frequency for 28.5%. Due the lifting, the pressure was measured needed to lift the gate. A reduce in the lift was obtained from 22 to 48% throughout the gate path.

All of the measurements done showed decreased values of the gate loads, whether they were vibrations or lifting loads. This shows that all the steps taken to refurbish the gate contributed towards improved gate performance. To validate the numerical

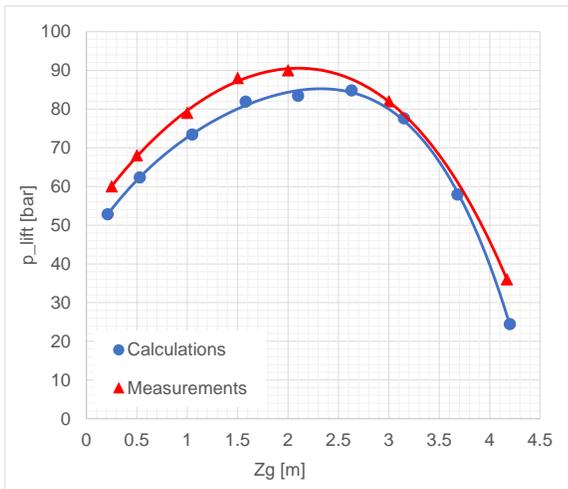
Figure 21. Lifting pressure comparison (CFD calculations + analytical models v.s. measured)

where G_z is the gate weight and F_{DP} are the CFD obtained down-pull (vertical) forces on the gate. This model showed good correspondence with the measured values of the lifting pressure of the gate (figure 21), showing that the CFD modelling coupled with the analytical methods are good predictive method for

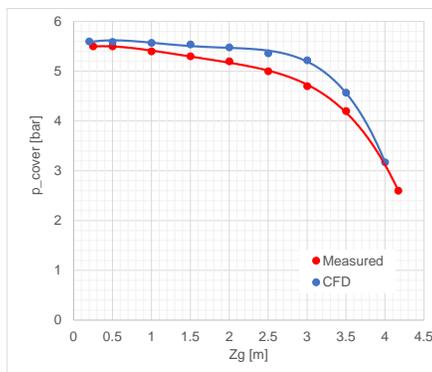
Figure 22. Pressure on the slot cover (CFD calculations v.s. measured)

estimating real loads and operating conditions. To validate the CFD model from another point of view, the static pressure on the gate slot cover were extracted from the simulations and compared with on-site measured pressure values (figure 22).
